Exposed Slope surface of the Dhalli Rockslide indicating extensively jointed surfaces causing wedge failure

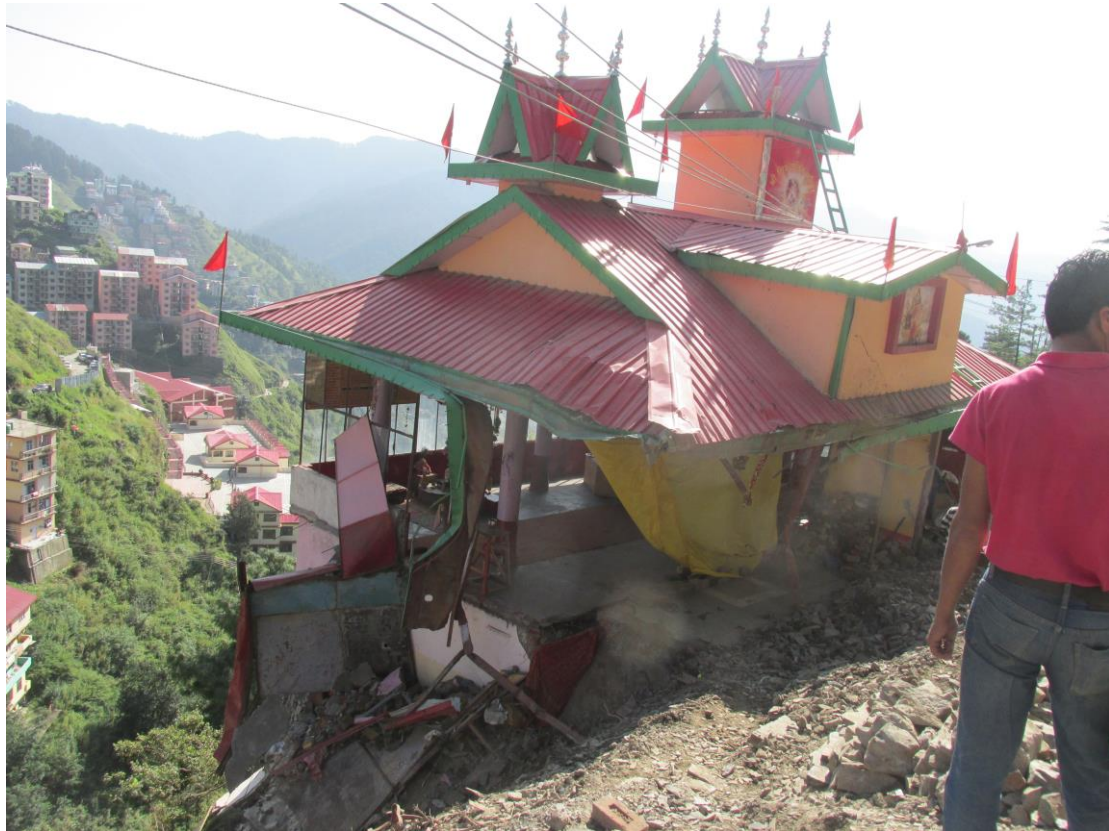
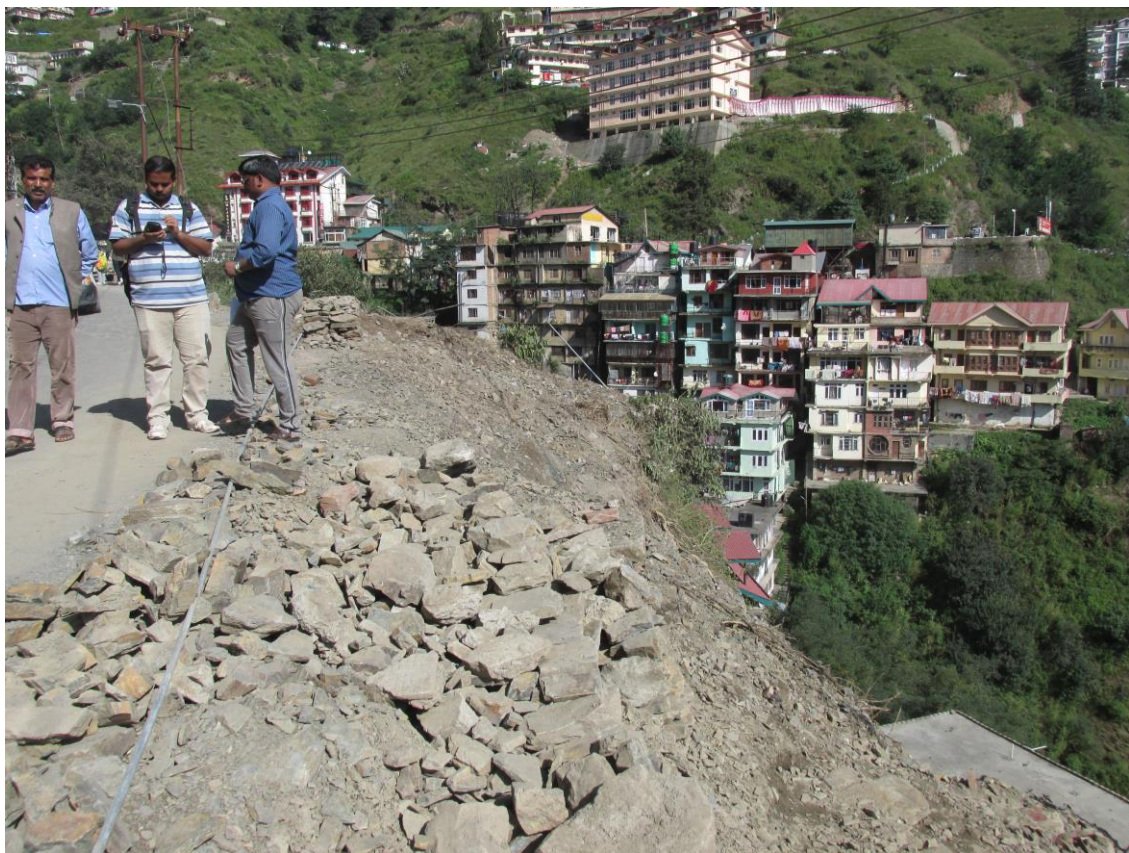
Post landslide field work with the supervisor revealed the settlements and vehicles damaged located along the downside of the slope.

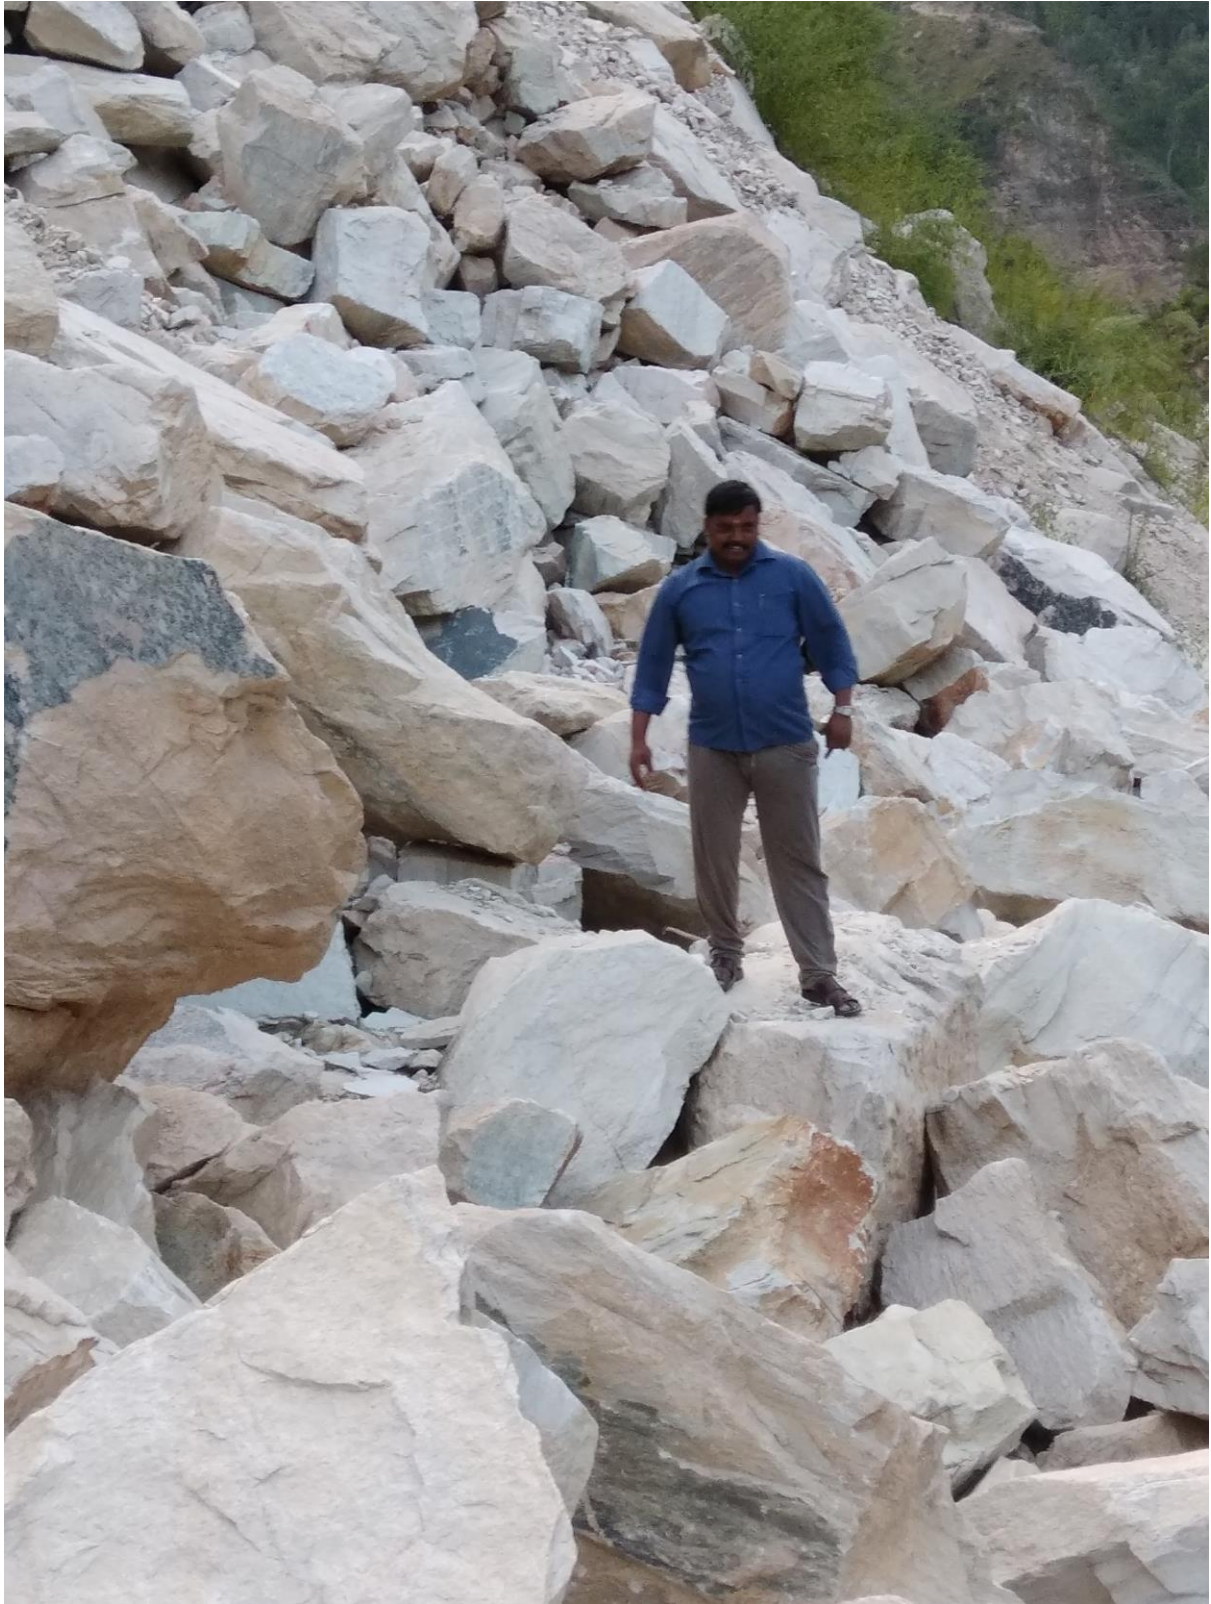
Filed work at the Jhakri landslide site indicating the dislodged blocks of rocks along the nearby slope at NH 22
